#### Weston Solutions, Inc.

REMOVAL SUPPORT TEAM 3 EPA CONTRACT EP-S2-14-01

May 5, 2016

SUBJECT: STRUCTURAL EVALUATION - NIAGARA FALLS BOULEVARD SITE

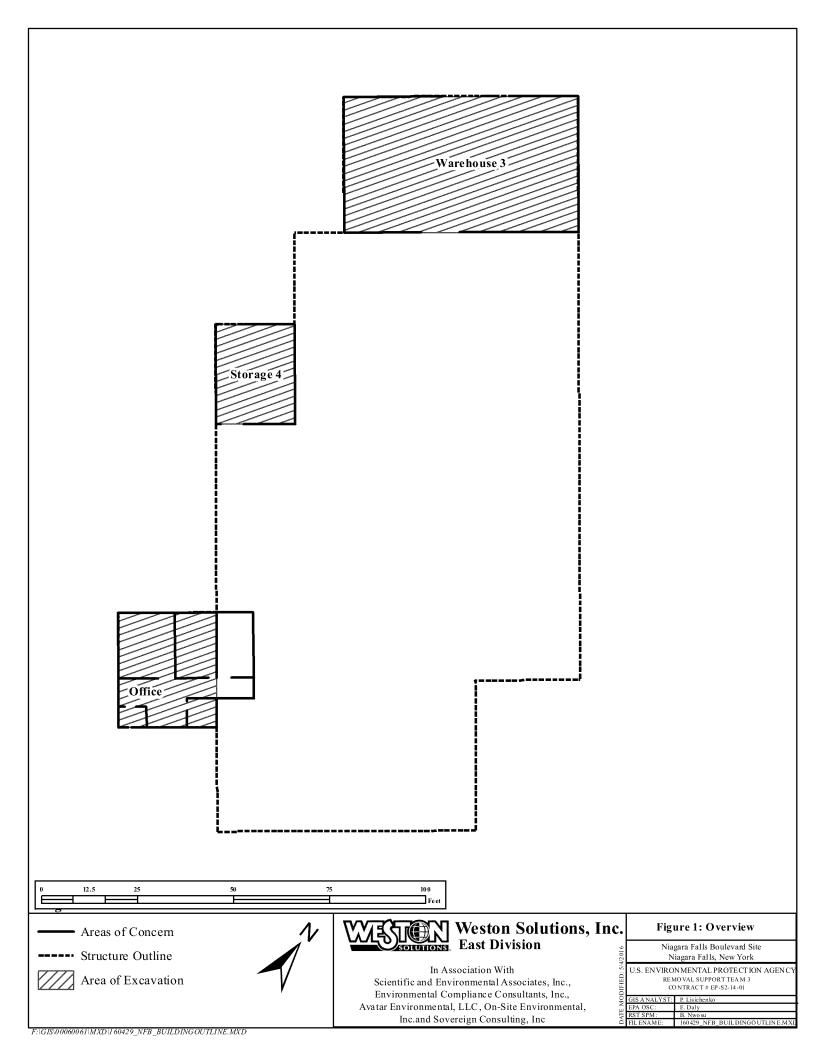
### Office Area (see attached Figure 2)

Walls marked NB: Non-bearing, wood-framed interior walls that bear directly on the top of the floor slab. These walls can be removed.

Walls marked LB: Load-bearing, wood-framed interior wall that bears directly on the top of the floor slab. This wall supports the roof joists spanning in the E-W direction. Roof joists need to be shored prior to removing wall. Wall to be removed in sections to access slab and soils below the wall and new footing installed prior to moving on to another section of wall.
